## FASTER THAN A SPEEDING BULLET

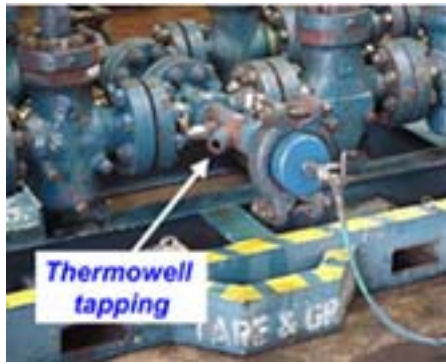
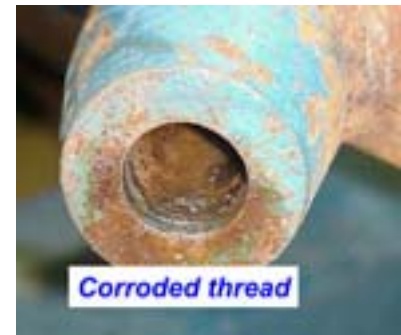
A piece of equipment was being pressure tested at approximately 5,000 psi. During the pressure check, two employees were inspecting for leaks. Without warning, a 3/4" threaded thermowell failed at the threaded joint, the force separated it at a very high rate of speed and it struck one of the employees in the leg, leading to a very serious injury.

- threaded connections can be weak points, especially if the threads are corroded, stripped or if the threaded connection is not fully made up
- these problems are often hidden from view; finding a problem may be possible only if the connection is disassembled and all threads inspected
- in the above incident, what made the accident very serious was the fact that someone was standing right in front of the thermowell when the joint failed

- While complete failures of joints are rare, they can and do occur. In this incident, the force on the thermowell was approximately 1-3/4 ton, and the failure propelled the thermowell at roughly **90 MPH**. When increasing pressure in equipment attempt to stand a safe distance away or behind barricades until the final pressure is reached.
- Whenever threaded connections are disassembled, inspect **BOTH** sets of threads for corrosion, signs of cross threading, etc. If there is a problem, get it repaired before putting pressure on the joint.
- Threaded connections can be "backwelded" - this will improve the overall strength of the joint. The disadvantage, of course, is now the joint can not be disassembled easily.
- For systems where significant corrosion is present, flanged connections are generally better than threaded.

**When threaded equipment is taken apart, look carefully for stripped threads, corrosion or anything that looks abnormal – it may be a WEAK POINT in your system!**
