Corrosion Under Insulation (CUI)

January 2014

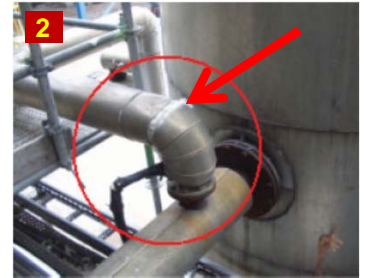
(1) and (2) – Examples of damaged insulation
(3) – Corrosion resulting from damaged insulation

- ➔ For process plant construction or maintenance workers:
 - Make sure that insulation is always installed according to the specified procedures. This includes proper covers and seals on the insulation, and proper coating or painting of the equipment which is insulated.

- If you must remove insulation, be sure to protect the removed insulation until the job is finished and the insulation is properly re-installed.
 - When you remove insulation to do a maintenance job, take advantage of the opportunity to look at the equipment under the insulation. If you see evidence of corrosion, report it to management so experts can inspect the equipment.

- ➔ For process operators:
 - Look for damage to insulation or other signs of CUI as you work in the plant, and report your observations to management so damaged insulation can be repaired and the insulated equipment can be inspected if necessary.

- When a maintenance job is complete, check the insulation to make sure it has been properly replaced.
- ➔ If you damage any insulation in the course of your work, report it and make sure it is repaired.
