December 2004

Bhopal—A Tragic Event

Union Carbide Bhopal Plant

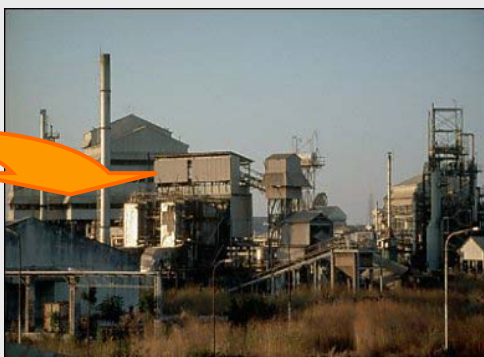
It was just after midnight, December 3, 1984 in Bhopal, India. A succession of events occurred in the Union Carbide India Limited facility that led to the release of ~40 metric tons of methyl isocyanate (MIC) gas. The consequences were tragic: according to the Indian government, more than 3800 people died shortly after the release and thousands were injured.

- ? The basic cause has been agreed upon by most experts who investigated this event: a significant quantity of water entered the MIC storage tank. Water reacted with MIC, temperature and pressure rose and several safety systems could not deal with the event. Eventually, the vessel's relief device lifted, releasing MIC vapor.
- ? 20 years later, the exact water source remains controversial. However, it is clear that installed safety systems did NOT prevent a large release of toxic gas.

- ☞ More than any other in the history of the chemical industry, this incident demonstrates why robust safety systems are critical when handling hazardous materials. This incident was also one of the driving forces which defined process safety management as we know it today.

- ☞ Understand the reactivity hazards of all materials in your process. Read the reactivity section of your MSDS's, fully understand all reactivity instructions in your operating procedures and be knowledgeable about why your safety systems (e.g. interlocks, relief devices, scrubbers) are there and how they work.

- ☞ If a material in your area reacts with water: 1) be cautious when washing equipment for maintenance or whenever a water hose is used, and 2) remember that compressed air may contain condensed water – be sure process air is free of water before blowing lines.

- ☞ Understand the emergency procedures you are to take if the temperature or pressure increases quickly in vessels storing hazardous materials, especially those which are reactive.

- ☞ Encourage your management and technical group to have a discussion about the “worst case” for the facility you work in and what safeguards have to be maintained to prevent that scenario from occurring.
