The Worst Ammonia Incident Ever - What Can We Learn? December 2023

Overfilling Vessels Can Have Catastrophic Results!

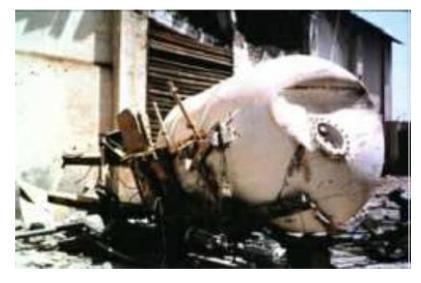
Figure 1. Front of the tanker

Parts of the tank truck after the explosion

Why did this event happen? The tank was not permanently installed; it was a tank truck that was filled at the ammonia supplier's site, then transported to the mill. The tanker was built to regulations and was 11 years old when it failed. Repeated overfilling of the tank led to overpressurization and crack formation. This was detected in 1991. Maintenance workers repaired the cracks and the tank continued to be used. The day before the incident, the tank was <u>filled to 124%</u> of the rated capacity.

- Critical process information such as maximum tank fill level should be noted on the tank, at the filling connection location and be a special warning in the filling procedure.
- Never overfill or exceed the rated capacity of a vessel. If more material is delivered than the rated capacity of the receiving tank, consult your supervisor.
- Repairs to tanks and other equipment require specialized expertise. If asked to perform a repair that you are not trained or certified to do, question it. Better to have a process delay than a process disaster.
- Read the <u>Chemical Engineering Progress</u> article about this incident free of charge at:
- https://www.aiche.org/resources/publications/cep/2023 /july/learning-worst-ammonia-accident
