Details Matter in Process Safety!

March 2015

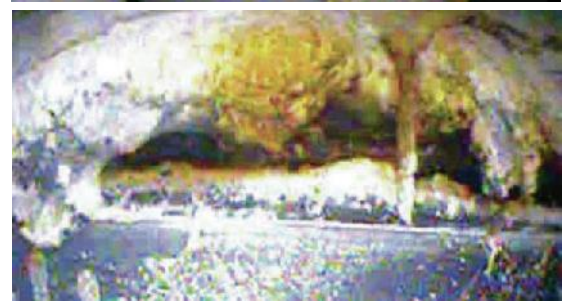
There was an exothermic reaction in a drum of radioactive waste material in a nuclear waste repository. The drum ruptured, releasing small amounts of radiation, exposing other waste drums to elevated temperature, and contaminating 20 workers with low levels of radiation. Other drums containing similar waste material may also be in danger of rupture. The facility had to be shut down and the recovery cost is expected to be several hundred million dollars.

A chemical reaction occurred in the drum, which contained acidic waste material and oxidizing chemicals including nitrate salts, as well as an organic absorbent. This mixture can react to generate heat and pressure.

While a final determination of causes has not been made, newspaper reports indicate that a typographical error in a revision to a facility policy may have resulted in the use of the wrong absorbent! The revised policy specifically stated that an organic absorbent should be used, when it should have specified the use of an inorganic absorbent (a clay based absorbent). The error was not recognized and the absorbent was changed, resulting in the incident. Details matter! Those two letters, “i” and “n,” make a huge difference in the characteristics of the absorbent!

- ❖ Whatever your job – operations, maintenance, supervision, engineering, management – pay attention to the details in your work. There are no unimportant details in process safety. You never know which apparently minor detail can initiate a major event, so you have to pay attention to all of them!
- ❖ If you are asked to review a procedure or other process safety information, really review it. Don't regard the review as a formality, go over it carefully.
