## **Runaway reactions caused by contamination**

February 2018

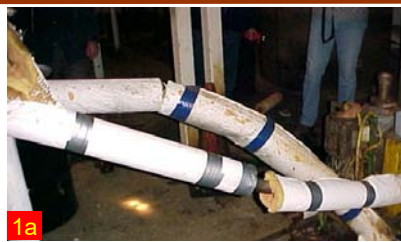
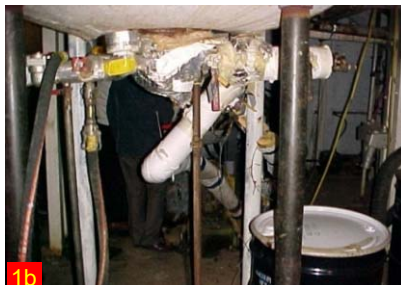
**Incident 1:** A pipe containing an organic residue from distillation processes and liquid drained from process vent systems was isolated by closed valves. The pipe was steam-traced to keep the residue from solidifying. During a weekend shutdown, the pipe exploded (Figures 1a and 1b). Nobody was injured because the building was not occupied, and damage was minimal.

**Incident 1:** The temperature control system on the steam tracing for the pipe had failed, resulting in high temperature. This should not have resulted in decomposition and explosion, but the residue had been contaminated with about 1% water. Water vapor from process vessels condensed in the vent system and drained into the residue tank. Laboratory tests confirmed that this amount of water reduced the decomposition temperature of the residue by about 100°C. The temperature resulting from the steam temperature control failure was high enough to initiate decomposition.

- When you check safety information (Safety Data Sheets, operating procedures, etc.) for materials in your plant, pay attention to possible hazardous reactions such as decomposition and polymerization as a result of contamination. Be aware of any specific contaminants of concern which are present in your plant.

- Some contaminants are common – rust, water, heat transfer fluids, lubricants, metals and other products from corrosion of pipes and equipment. Know if any of these common contaminants are of concern for your process.

- Recognize that even a small amount of contaminant can be enough to cause a dangerous reaction.
- Follow all procedures for avoiding contamination in your plant and equipment. Take special care to verify the identity of materials before unloading into storage tanks or other plant equipment.

- Make sure that pipes, vessels, and portable containers that you use are clean. “Clean” means free from deposits, residue, rust, or other contamination as appropriate and defined by your plant procedures for the specific service.

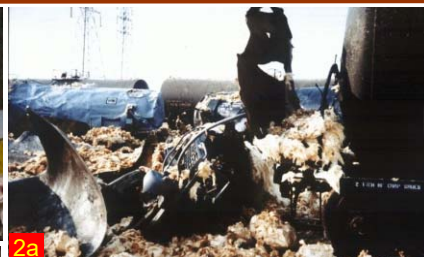
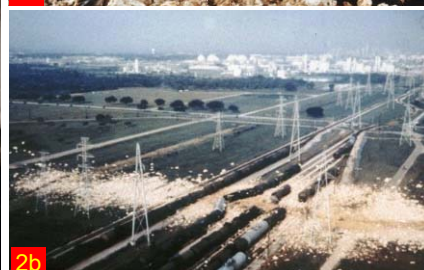
**Incident 2:** A railroad tank car containing crude methacrylic acid (MAA) was observed to be hot and venting material from its relief valve. The area was evacuated, and after some time the rail car exploded, destroying the car and causing significant damage in the area (Figures 2a and 2b). Because people had evacuated, there were no injuries.

**Incident 2:** Crude MAA contains strong mineral acids from the manufacturing process which corrode stainless steel. The dissolved metal from corrosion increases the tendency of MAA to polymerize. Crude MAA is supposed to be stored in lined tank cars, but, in this incident, an unlined stainless steel tank car was used. Also, the plant did not add the specified amount of polymerization inhibitor to the crude MAA. The inhibitor stabilizes MAA by stopping slow polymerization that occurs, even in pure material. The metal contamination from corrosion of the tank car may have induced the polymerization, and the reduced inhibitor concentration diminished the stability of MAA, ultimately leading to the runaway polymerization and explosion.

- Always use the correct material of construction for all components when doing maintenance in your plant.
- Confirm that containers you fill (pails, drums, tank trucks, rail cars, etc.) are the correct material of construction.
