## The study of Influencing Maintenance Factors on Failures of Two gypsum Kilns by Failure Modes and Effects Analysis (FMEA)

**Key words:** FMEA, Safety, Kiln, Maintenance system

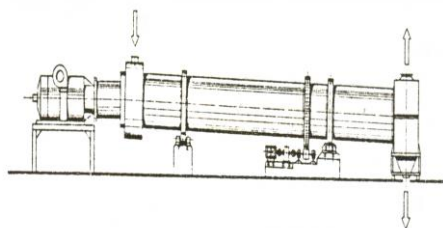
**Fig. 1:** Construction of longitudinal kiln of company No.1

The production processes in two companies were nearly the same. The most important difference between them was the relevant to kilns types which were direct revolving and triplex in no.1 and no.2, respectively. Gypsum stones were transferred to factory and then shoot to special screens for separation the proper size and convert to them hammer crusher. After crushing, the materials transferred to kilns for cooking. The construction of kilns of no.1 and no.2 are presented in Figures 1 and 2.

- The rotation of kilns caused to the torque of kilns. The torque of NO.1's kiln was more than NO.2's because of its higher length.
- Because of the less longitudinal expansion and less torque of NO.2's kiln, slipping effect (the slip of kiln because of angle between kiln longitudinal axes and horizontal line) was negligible. This phenomenon was so low that there was no necessity to use lifter and therefore there were no failures of rubbing and tearing of lifting roller surface and fracture of roller's shaft.
- The thermal efficacy of kiln NO.2 was higher than NO.1's because the NO.2 kiln was built up from concentric three cylinders. The heat was transferred from inner cylinder to the outer ones and therefore the heat loss was kept as low as

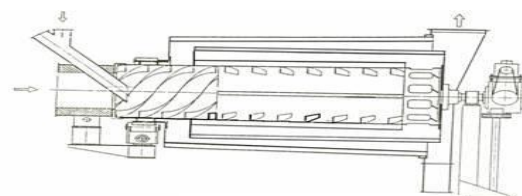
**Fig. 2:** Construction of triple layer kiln of company No.2.

possible. Because of high thermal efficiency and shorter length of NO.2 kiln, the failure rates of Kiln shell deformation, Shrink of kiln shell near tire, Kiln exit stretch, cracks on junction of main gear, falling of kiln bricks, Kiln shell spot were zero.

- The disadvantage of NO.2 kiln from NO.1's was the lack of quick access to inner parts of kiln for inspection and maintenance operations. It was impossible watching out inner parts and it was necessary to use some monitors for inspection.

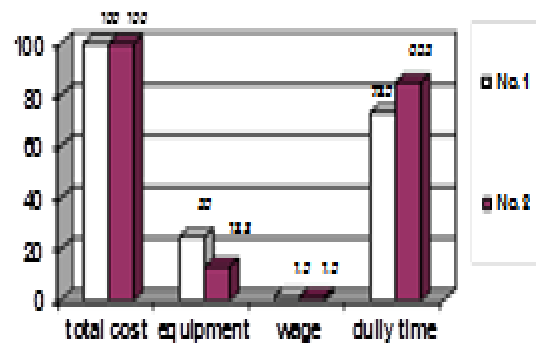
**Fig. 3:** Contribution of equipment, wage and non-productive time to total cost of No.1 kilns' failures

The study of maintenance cost showed that the total cost of No.1's and No.2's kilns were 160,732 and 60,082 million Rials, respectively. Figure 3 shows the contributions of equipment, wage and non-productive time in total cost of No.1 and No.2. The maintenance cost (million Rials) in terms of failure severity is shown in figure 4.

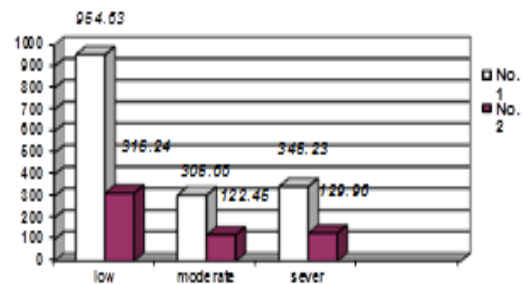
**Fig. 4:** Maintenance cost in terms of severity of failures

Considering the relation between repair cost and severity of fails showed that the low severity fails had the most cost (Figure 4). One of the most important reasons for this issue was neglecting the low severity fails by personnel and using the improper material equipment in reparation. Finally this study showed that the design and construction of kilns are most important variables in reduction of fails.
